Poor passage plan means ship is unseaworthy

Pre-load Steel Surveys and Ultrasonic Hatch Cover Tests

The greasing schedule

Accident investigation world round-up

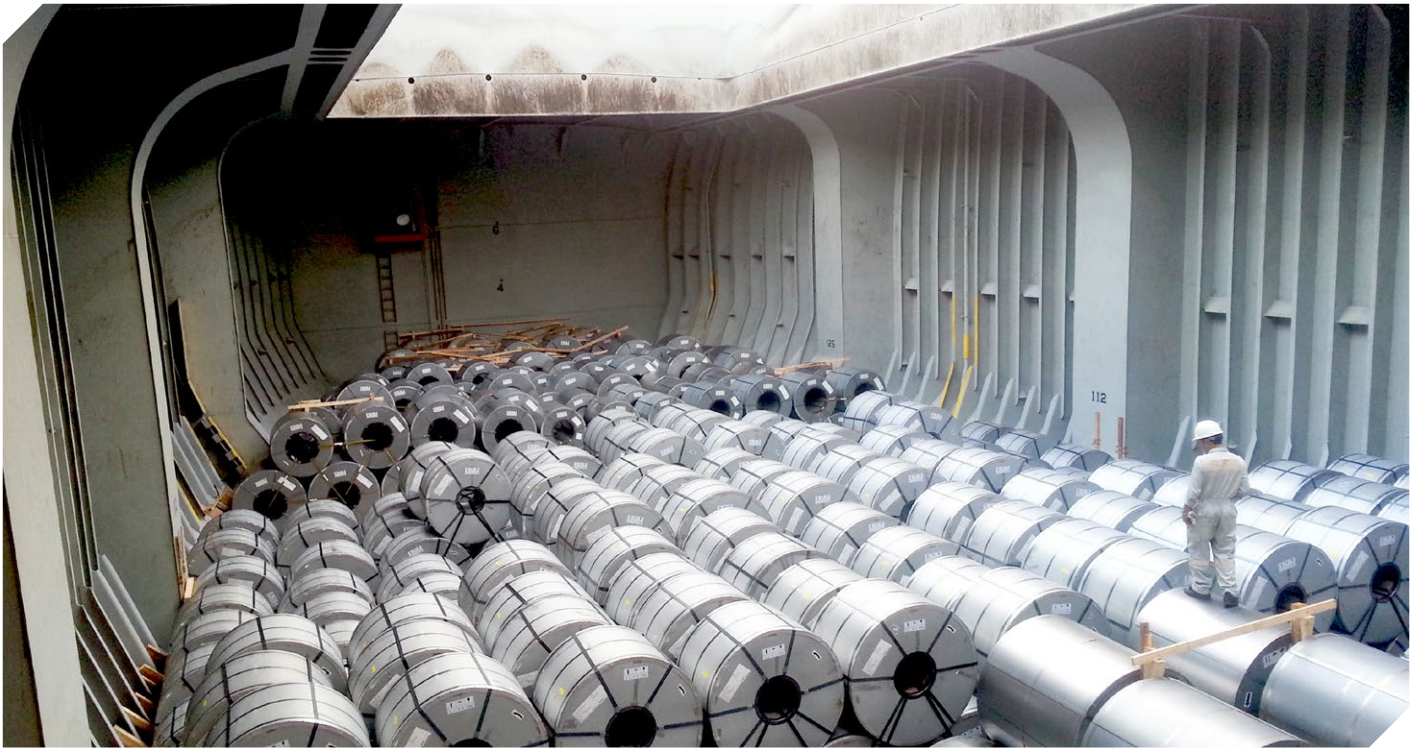
Pre-load Steel Surveys and Ultrasonic Hatch Cover Tests

The London P&I Club has maintained the Pre-load Steel Survey (PLS Survey) programme since the late 1970s. This involves the survey of the condition of finished steel cargoes as presented for loading. This provides the Master with correctly expressed clauses to insert on the Mate's receipts and subsequent Bills of Lading. The programme also includes the ultrasonic hatch cover test (UHCT) to reduce the risk of water ingress through hatch covers on voyages.

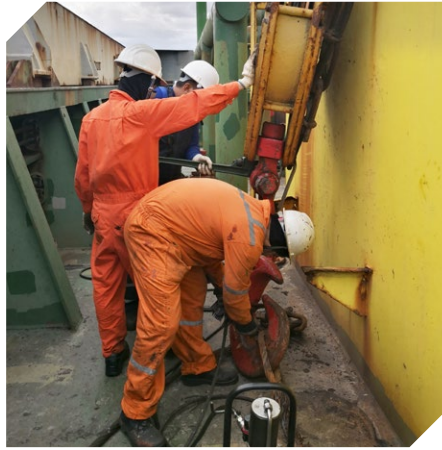
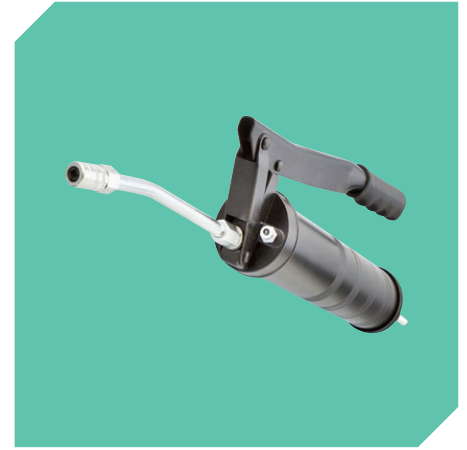
The greasing schedule

An effective way to prevent common ship inspection issues on deck is to have a regular maintenance task that requires the periodic greasing of various items.

The most common finding related to greasing during ship inspections is seized or inoperable fire dampers.

Other related findings during inspections are seized dolly rollers and roller

fairleads. Clear contractual implications for owners can arise from the poor maintenance and lubrication of crane wires. It's clear that the lack of lubrication can compromise the wire and reduce its life – but the use of incorrect wire lubricant is often noted.

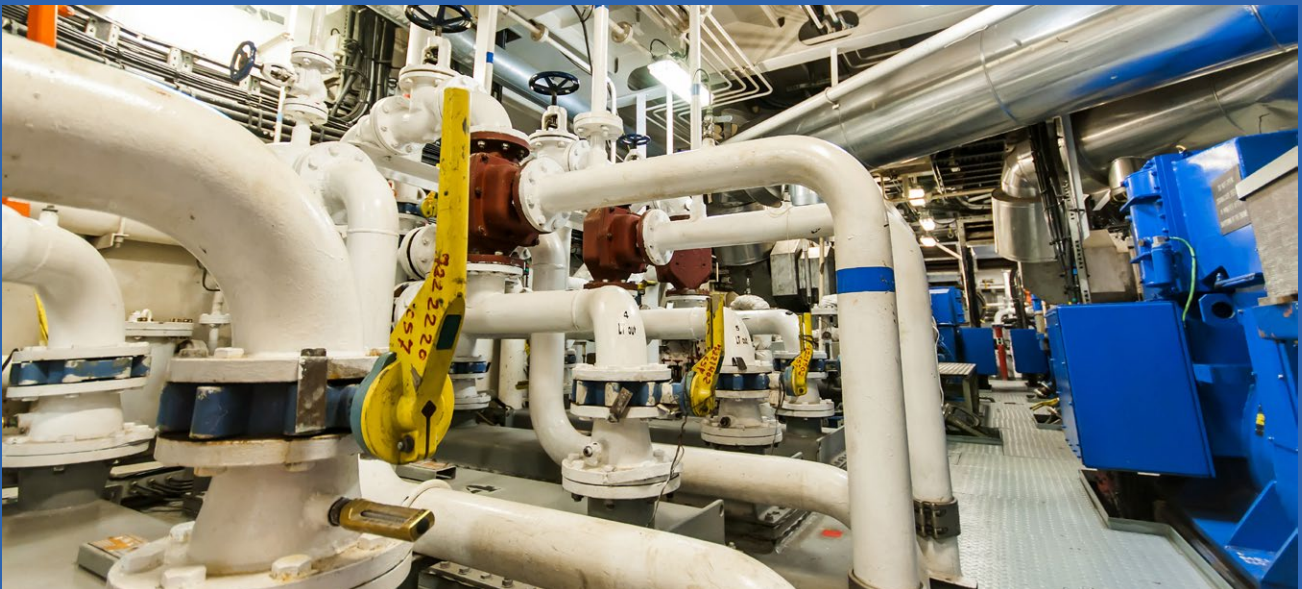
Tracing Lines

It used to be a standard task for joining officers in the engine room, and on deck in the tanker industry, to 'trace lines'. Tracing lines is the simple yet vital task of identifying all lines in machinery spaces and on deck to establish their purpose, origin and destination.
